Inspection Survey Report

SNAG-RIGHT
PROFESSIONAL NEW HOME INSPECTION

Name	Mr Smith		
Address	5 Smith Lane, Edinburgh		
Plot Number	16		
Date of Inspection Survey	20/04/2021		
Signed permissions granted for Inspection Survey	Camera	Bodycam	Audio
	✓	✓	✓
Inspector			
Property type/No. bedrooms	Detached, 3-bedroom house		
House builder	Smith Homes		
Development name	Kings Gardens		
Completion date	17/04/2021		
Warranty provider	NHBC

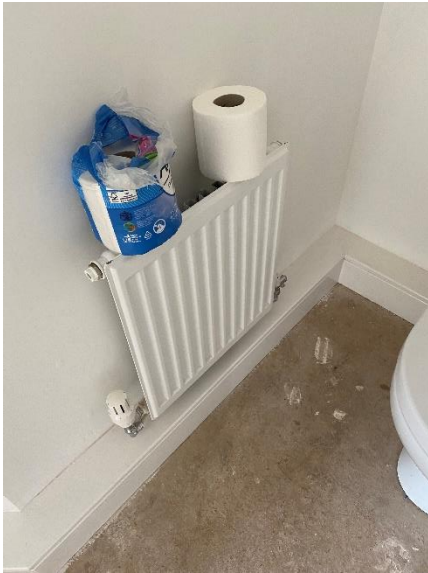
1

1. W/C radiator not heating up fully
2. Upper hall radiator not heating up fully
36. Bedroom 3 radiator pipe sagging down below radiator and visible
84. Sealant to be put around gas flue for boiler

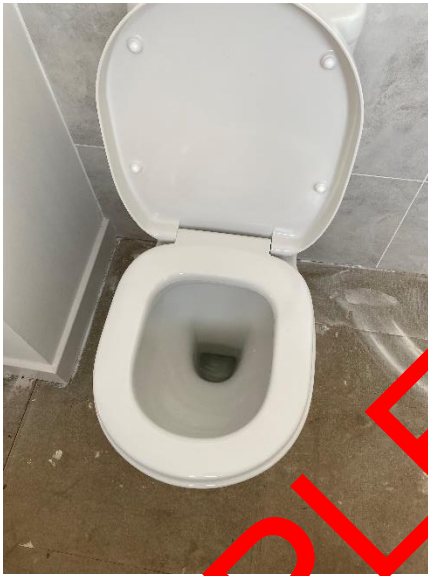
3

3. Toilet continuously trickling into bowl
4. Floor and waste pipe should be adequately sealed behind toilet
10. Shower rail in shower cubicle is loose and needs secured properly
16. Holes in floor behind sink should be filled

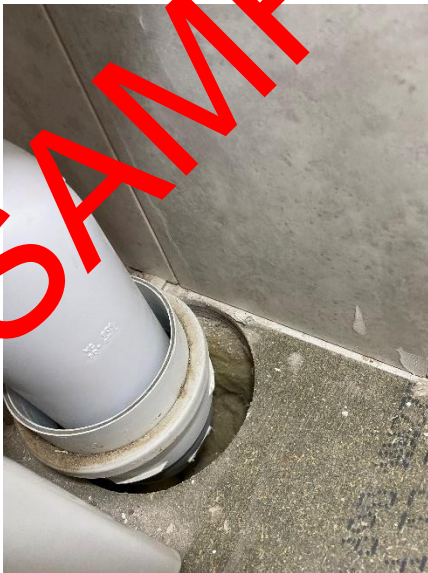
5

- 5. Floor and waste pipe should be adequately sealed behind toilet
- 12. Split in external corner of bath panel at top

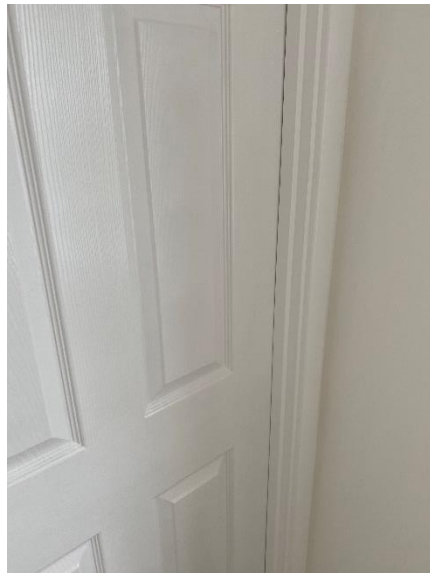
6

6. Door is binding at door stop and needs adjusted
11. Shower screen door is stiff and difficult to open and needs ease off
13. Door leading into linen cupboard is very rough and needs sanded and painted
21. Door to linen cupboard very stiff and needs adjusted

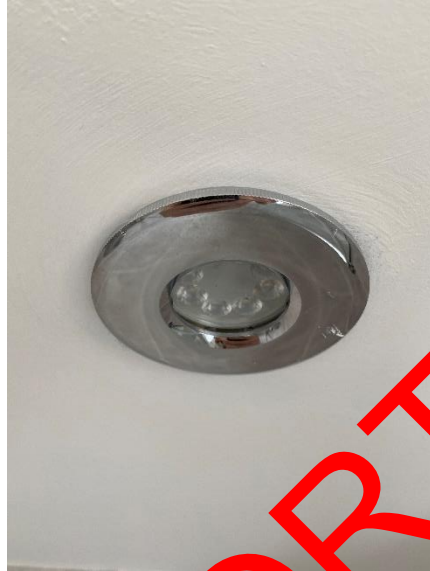
8

7. Door edge requires another coat of paint
8. Spotlight above shower has paint on it
9. Shower head handle has paint on it
15. External corner wall at skirting level beside shower tray untidy with filler and needs sanded and decorated
18. Excess filler on window frame
19. Linen cupboard paintwork incomplete to timbers
20. Linen cupboard, paint missed on facing on side of cupboard

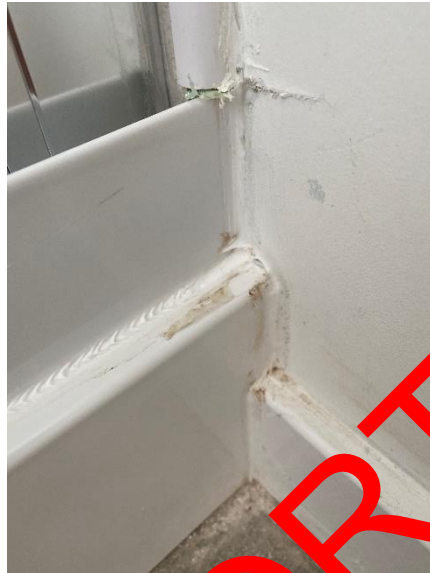
14

14. Silicon sealant on top of skirting plate below shower tray very untidy

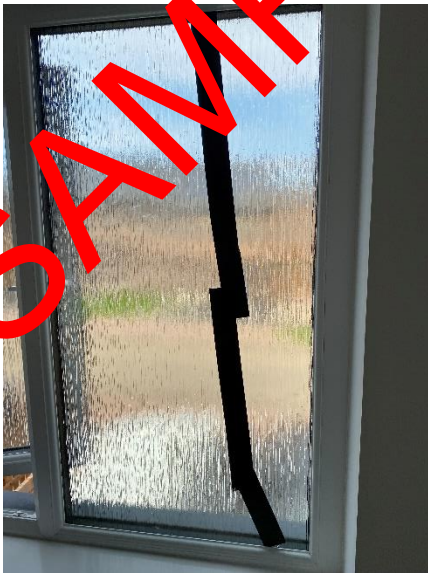
17

17. Right hand window pane cracked

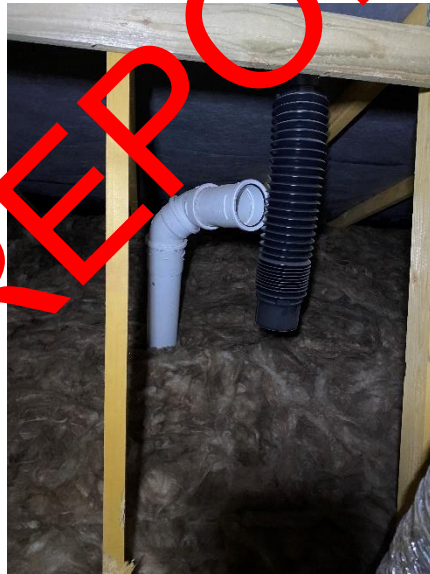
22

22. Extractor leading to roof vent has disconnected

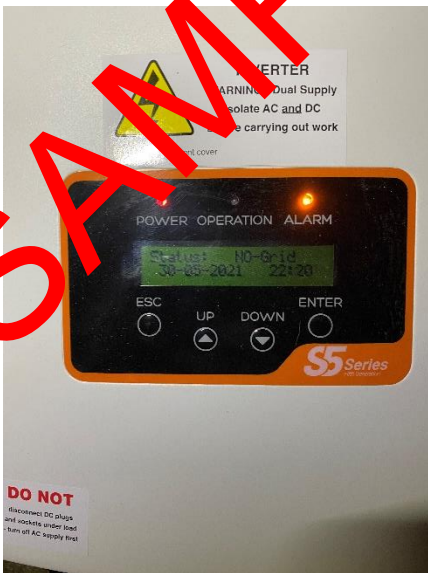
23

23. Solar panel meter is reading the wrong time and reading 13.20pm and time of inspection was 3.30pm. Control panel displaying a No Grid message and meter is reading all zero's. Doesn't appear to be connected.

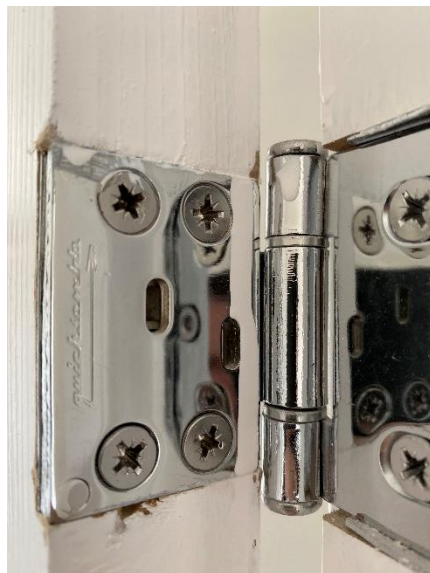
24

- 24. Paint on hinge on en-suite door
- 25. Bedroom door edge needs painted as appears only to have been primed
- 26. Bedroom door needs another coat of paint on the inside of the door
- 27. Dirty mark at a high level on wall opposite en-suite

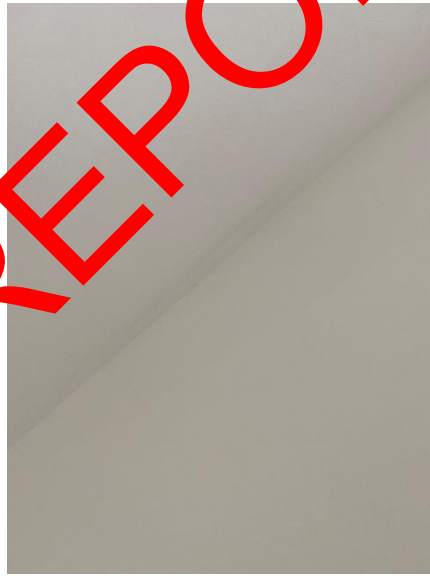
28

28. Visible brush marks on wall along joint between ceiling and wall left of bedroom window, needs sanded and repainted

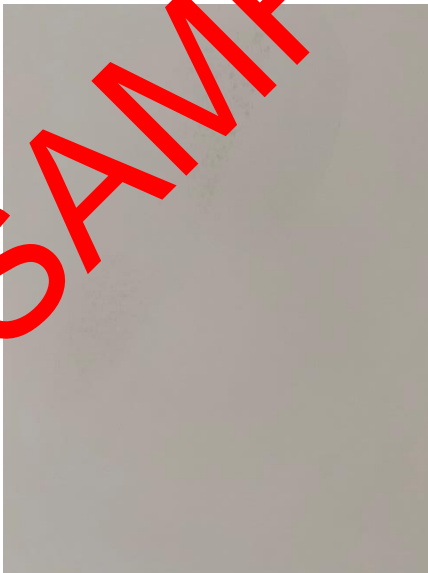
29

29. Filler and unpainted patches on ceiling, needs sanded and repainted

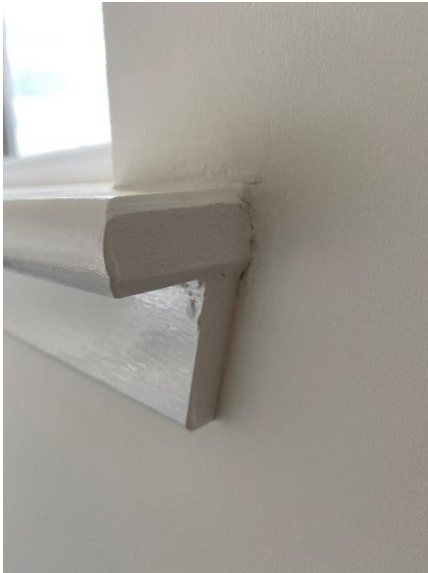
31

31. Right hand end of windowsill poorly decorated

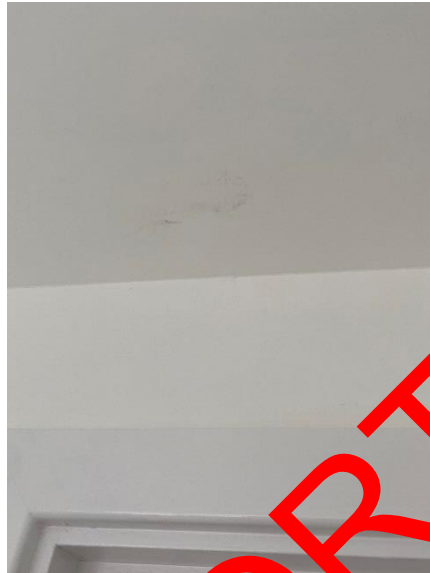
32

- 32. Dirty mark on ceiling
- 33. Dirty mark on wall, low level beside skirting, in the space allowed for wardrobe
- 34. Bedroom 3 door appears to need another coat of paint on the inside of the door (bedroom side)
- 35. Bedroom 3 door needs painted on inside face and on door edge
- 37. Top corner between wall and ceiling opposite window, decoration needs improved

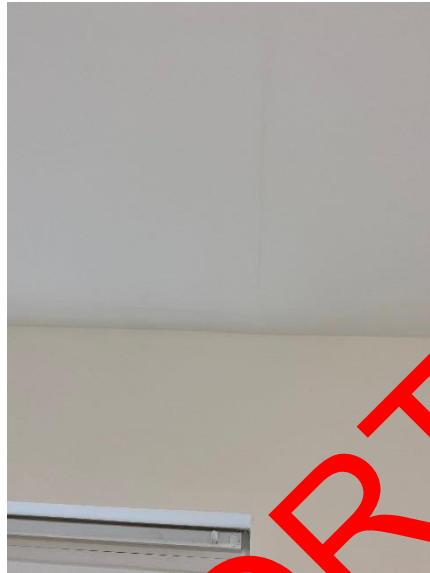
38

- 38. Visible join on plaster board on ceiling beside window
- 39. Missed paint on ceiling behind extractor fan
- 40. Inside face of door needs sanded back and re-painted, appears to be residue of a sticker or tape
- 42. Poor paintwork above tile trim above bath
- 43. Left hand side of window at windowsill, filler, sanding and decoration is poor and requires improvement

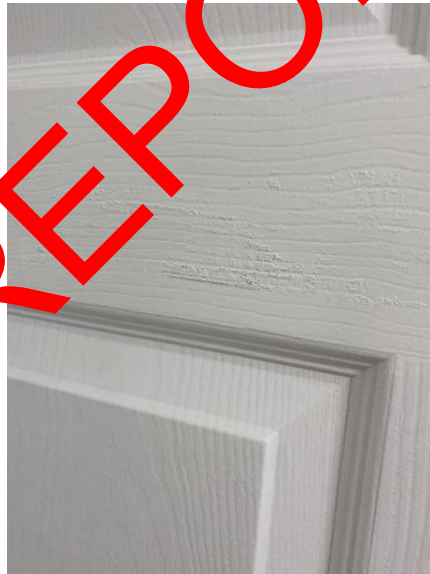
40

Unable to check operation of bedroom 2 door as carpets obstructing the door (see photo 40).

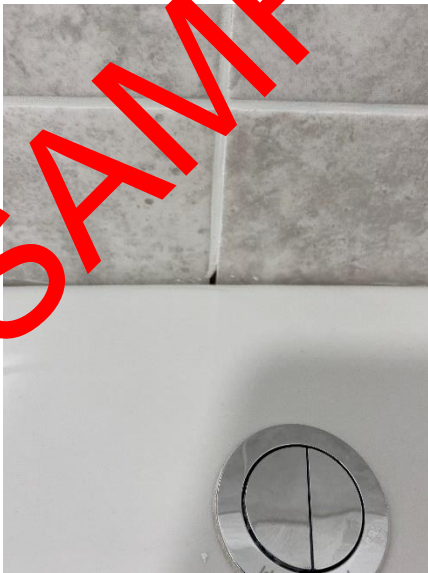
41

- 41. Grout missing from tile trim directly above toilet system

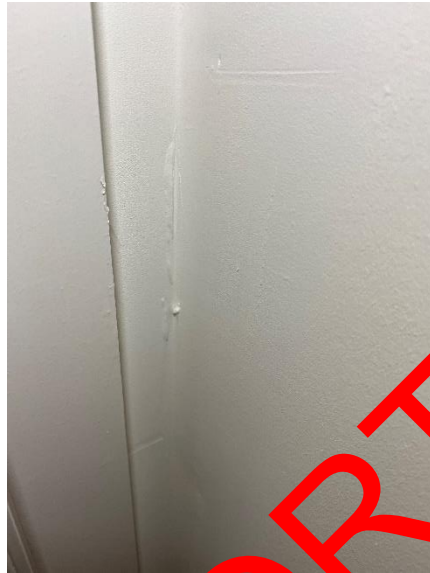
44

- 44. Inside upper hall cupboard, the inside of the facing needs improved
- 45. Mark on ceiling at top of stairs
- 46. Mark on ceiling beside loft hatch
- 47. Filler on door facing leading to bedroom 3, needs sanded and decorated

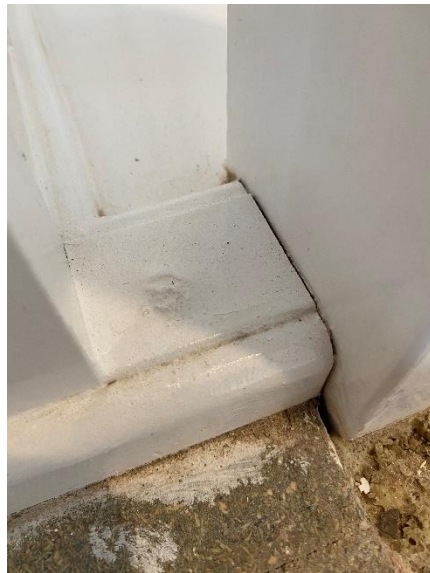
48

- 48. Base rail at newel post at top of stair, the filling sanding and painting is poor, needs improved
- 49. Newel post at top of stair, the filling, sanding and painting is poor and needs improved
- 53. Filler to bottom of stair is very poor and needs improved

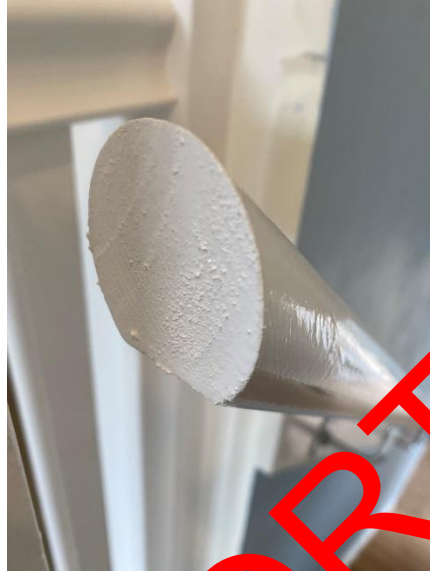
50

- 50. End of handrail at top of stairs is roughly sawn and needs sanded before decoration
- 51. Dents and damage to handrail of stair and needs repaired and decorated
- 52. Dents and damage to handrail of stair and needs repaired and decorated

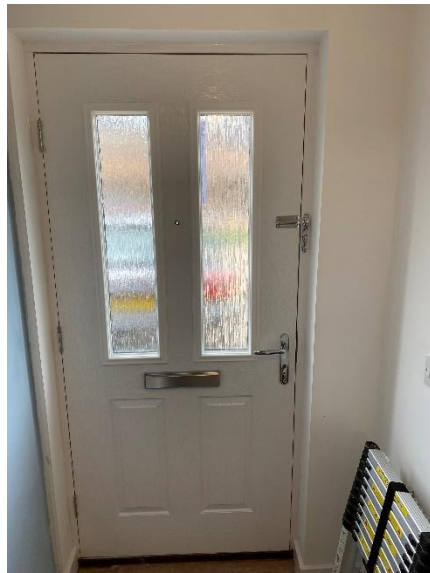
54

54. Front external door needs adjusted as not closing tightly at top

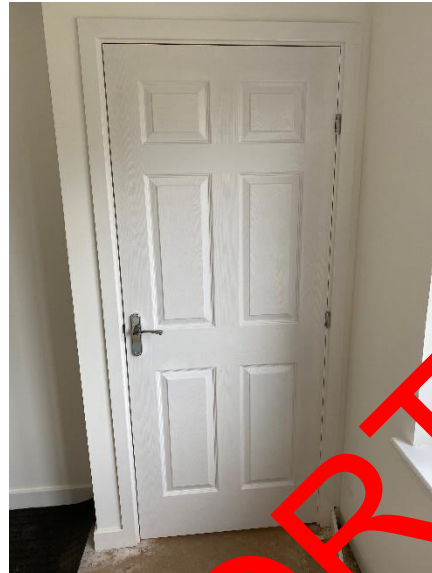
56

- 56. Lounge door needs adjusted as rattling in the frame

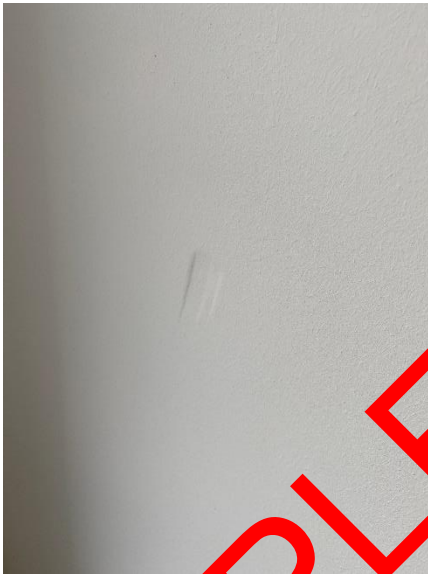
57

- 57. Right of lounge window, large gouge on wall
- 58. Lounge door edge appears to require another coat of paint
- 59. Right hand side of windowsill, decoration needs improved
- 60. Lounge to kitchen door needs another coat of paint as looks like it has only been primed

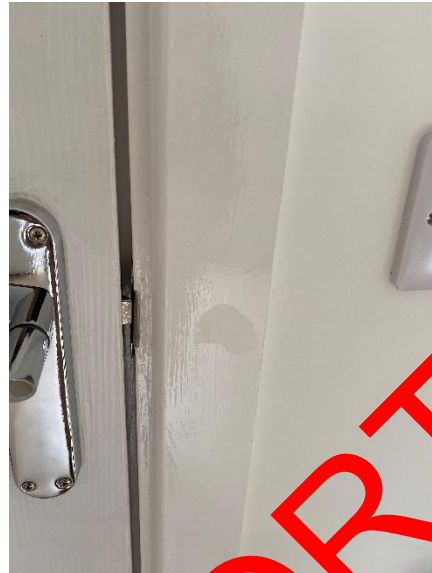
62

- 61. Door from kitchen to lounge, needs another coat of paint as looks like it has only been primed
- 62. Right hand facing of door leading to lounge has filler on it and requires sanding and decoration
- 63. Decoration above boiler unit needs improved

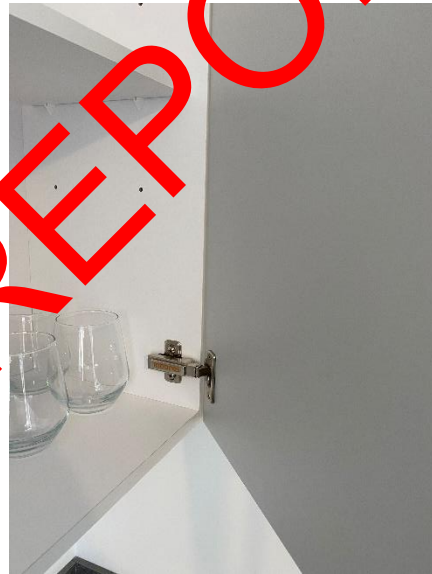
64

- 64. All kitchen unit doors appear to be missing soft close hinges
- 66. Kitchen unit drawers appear to be missing soft close mechanisms on them
- 67. Kick plate below sink does not appear to be fixed properly

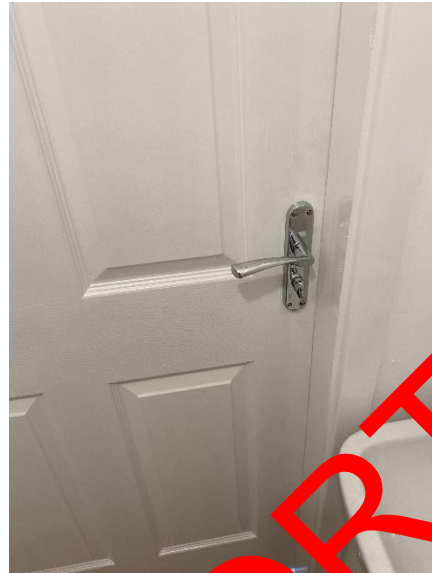
68

- 68. Door needs adjusted so that lock can be turned
- 69. Damaged door frame above door handle
- 73. Collar should be fitted around hole underneath sink where water pipes go into wall
- 75. Damage to door frame on left hand side (opposite door handle), needs repaired

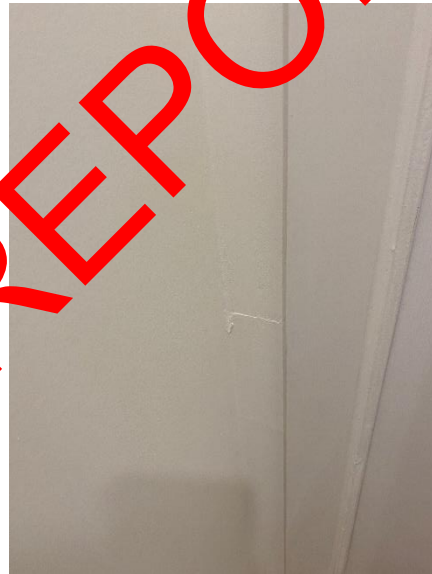
70

- 70. Wall on left hand side of door, general filling, sanding, preparation is poor and needs improved
- 71. Above sink on wall, general filling, sanding, preparation is poor and needs improved
- 72. Below sink on wall, general filling, sanding, preparation is poor and needs improved
- 74. Low level pipe box is poor and requires preparation, sanding and decoration

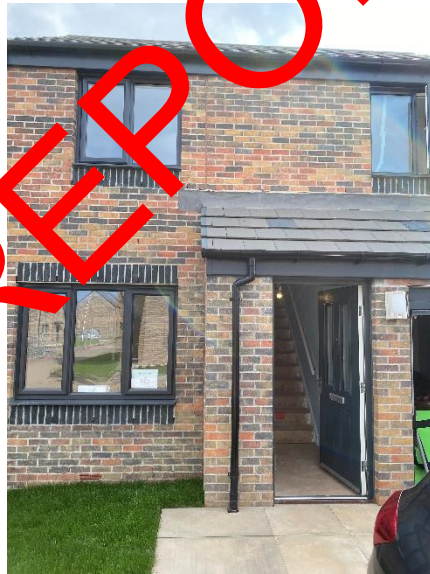
76

- 76. Plot would benefit from general cleaning of brick work to remove excess mortar from face of bricks,
- 77. Excess amount of cement to be removed from face of bricks around front door, untidy work
- 78. Pointing along top of lead flashing on porch roof to be improved as missing in places
- 79. Lead flashing damaged and dented on left hand side of porch roof
- 80. Cream coloured pointing between dark grey bricks below top floor windows is poor and could be made neater

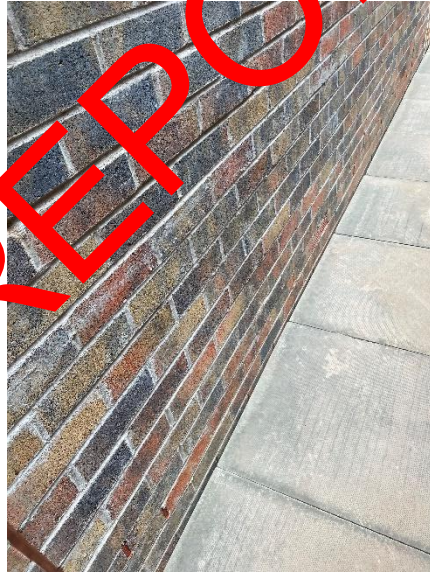
82

- 81. Excess cement or mortar to be removed from plastic verge caps at roof level
- 82. Excess cement or mortar to be removed from brick work along footpath
- 83. Cement or mortar to be removed from air vent and brick
