Inspection Survey Report

SNAG-RIGHT
PROFESSIONAL NEW HOME INSPECTION

Name	Mr Smith		
Address	5 Smith Lane, Edinburgh		
Plot Number	16		
Date of Inspection Survey	20/04/2021		
Signed permissions granted for Inspection Survey	Camera	Bodycam	Audio
	✓	✓	✓
Inspector			
Property type/No. bedrooms	Detached, 3-bedroom house		
House builder	Smith Homes		
Development name	Kings Gardens		
Completion date	17/04/2021		
Warranty provider	NHBC

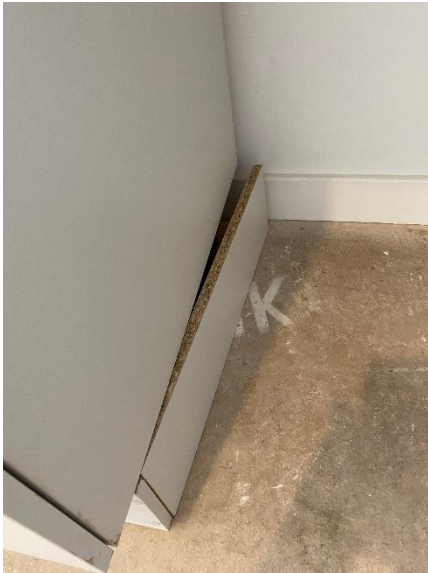
67

- 64. All kitchen unit doors appear to be missing soft close hinges
- 66. Kitchen unit drawers appear to be missing soft close mechanisms on them
- 67. Kick plate below sink does not appear to be fixed properly

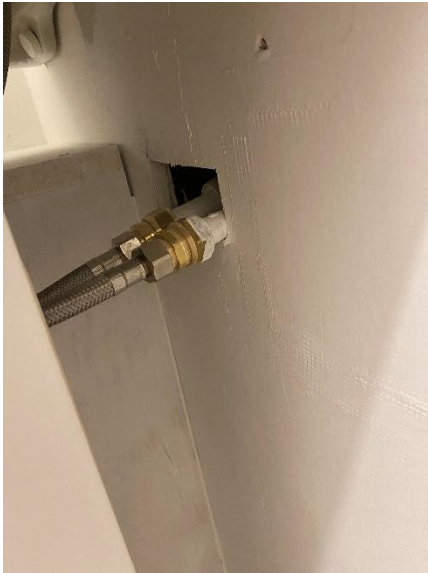
73

- 68. Door needs adjusted so that lock can be turned
- 69. Damaged door frame above door handle
- 73. Collar should be fitted around hole underneath sink where water pipes go into wall
- 75. Damage to door frame on left hand side (opposite door handle), needs repaired
